Montgomery County Fire and Rescue Service

POST INCIDENT ANALYSIS

**Third Alarm Apartment Fire
14201 Weeping Willow Dr
Silver Spring, MD 20906**

February 17, 2012

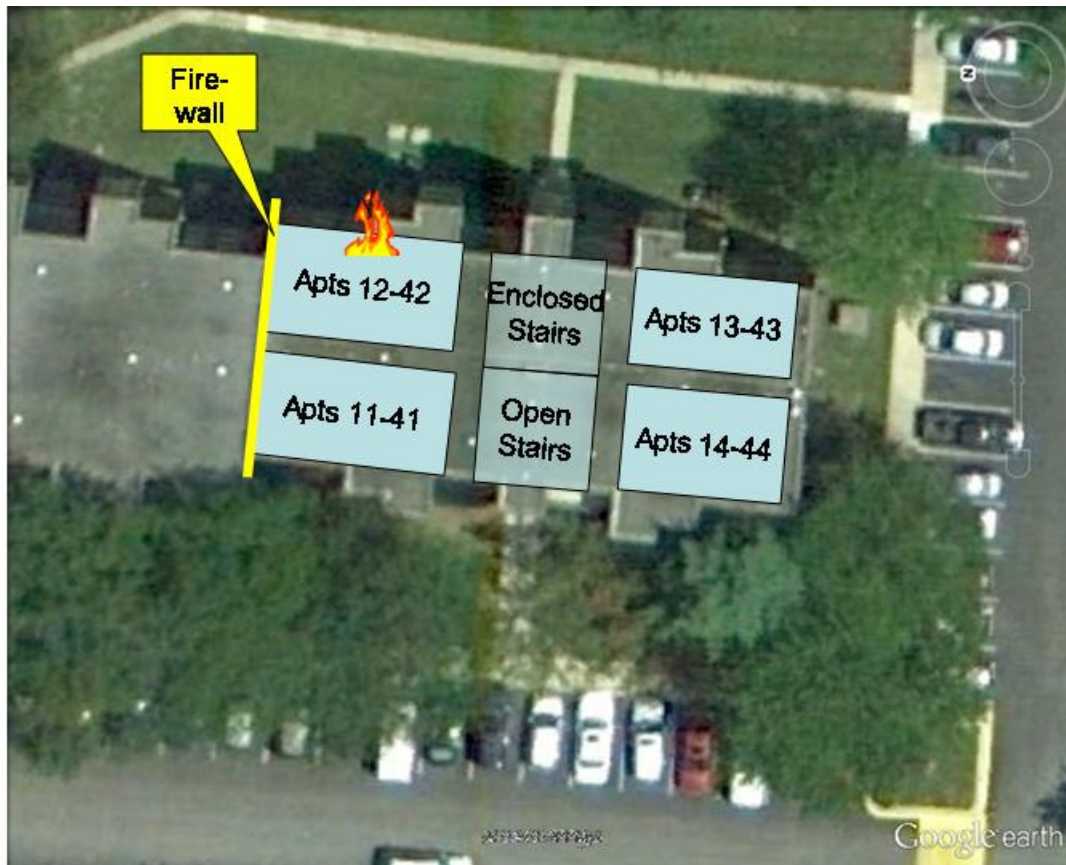
The fire building is a 4 story garden apartment of mixed construction: ordinary and wood frame. It is connected to 14205 Weeping Willow Dr (exposure bravo), but separated by a masonry fire wall. An open stairwell faces the front of the building with a landing on each floor. All of the apartments are accessed via these landings.

There is also a semi-enclosed stairwell facing the rear of the building. Fire doors on each floor separate the landings from the enclosed stairway. From the front entrance, it is possible to walk through a fire door and exit to the rear of the structure. Parking is situated on side alpha and delta. A sidewalk and turf make up access to Side Charlie.
